NIOSH
Fire Fighter Fatality Investigation
and Prevention Program

A Summary of a NIOSH fire fighter injury investigation

February 5, 1999

Oxygen Regulator Flash Severely Burns One Fire Fighter - Florida

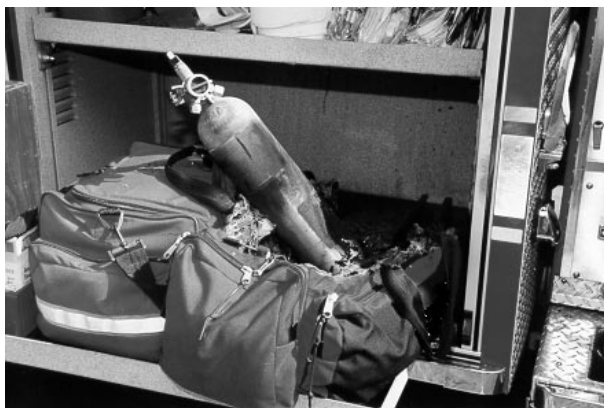
Oxygen Resuscitator Involved in Incident

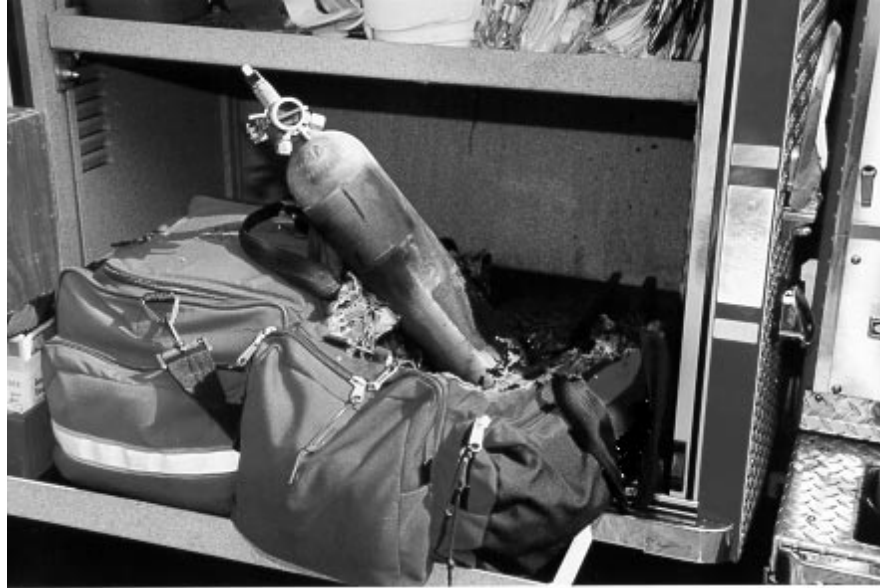
Photo 1: This photo depicts the airway bag which contained an aluminum cylinder filled with 99.7% pure oxygen, an aluminum regulator attached to the cylinder, and airway supplies.

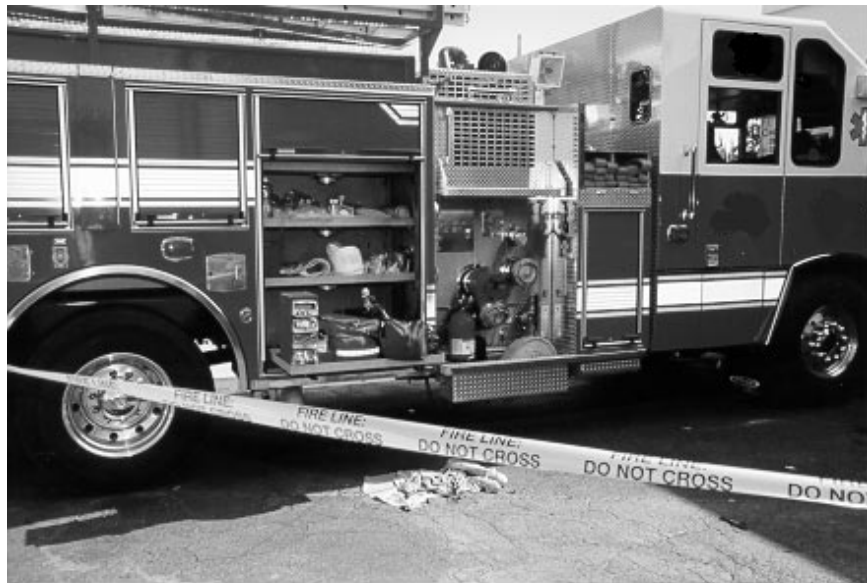
valve, the cylinder emitted a loud popping sound and then flashed, releasing two 4-foot flames, one toward the victim and the other toward the Engine (Photo 2). The victim turned, pushing the cylinder away, and fell to the ground with his clothes ignited from the waist up. One of the fire fighters, who was washing the other side of the Engine, stated that he heard a noise which sounded like one of the brake lines had burst. As he leaned under the Engine to check the lines, he saw the victim fall to the ground surrounded by flames. The other fire fighter washing the Engine stated that he watched the victim open the cylinder valve and heard the cylinder emit a loud pop and then flash, releasing two 4-foot flames, one toward the victim and the other toward the Engine. The fire fighter who witnessed the incident called for the other fire fighter washing the Engine to bring the hose he was using around to the victim. The fire fighter stretched the garden hose around the Engine, and spraying water on the victim, extinguished the flames approximately 10 seconds after the cylinder flashed. The fire fighter then turned the hose on the cylinder, which was emitting a loud whistling sound. The cylinder continued to burn for approximately 30 to 40 seconds before the fire was completely extinguished. The fire fighter turned the hose back on the victim, trying to cool him down as the on-duty medical personnel provided assistance. They removed his shirt and wrapped him in a burn blanket, and approximately 2 to 3 minutes later, he was placed in a rescue vehicle. A fire fighter/medic who had just arrived to start his shift saw the commotion, and proceeded to the rescue vehicle. The medic entered the rescue vehicle and took over medical responsibilities. The medic stated that en route to the local trauma center, they secured the victim's airway, started intravenous fluids, and flushed his eyes. During transport, the medics reported that the victim had approximately 35 to 40 percent first-, second-, and third-degree burns. The victim was later air-lifted to an area burn center.

Photo 2: This photo depicts the incident scene where the victim was severely burned.

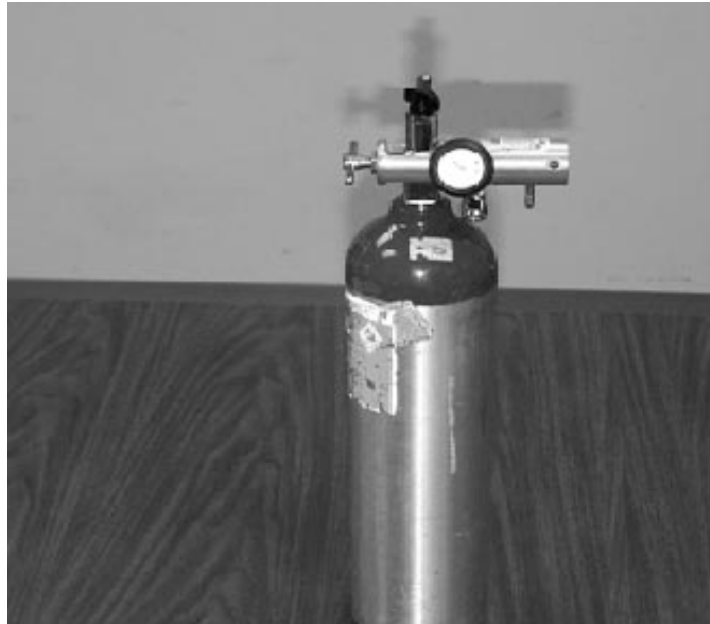
Photo 3: This photo depicts a D-size cylinder similar to the one that was involved in the incident.

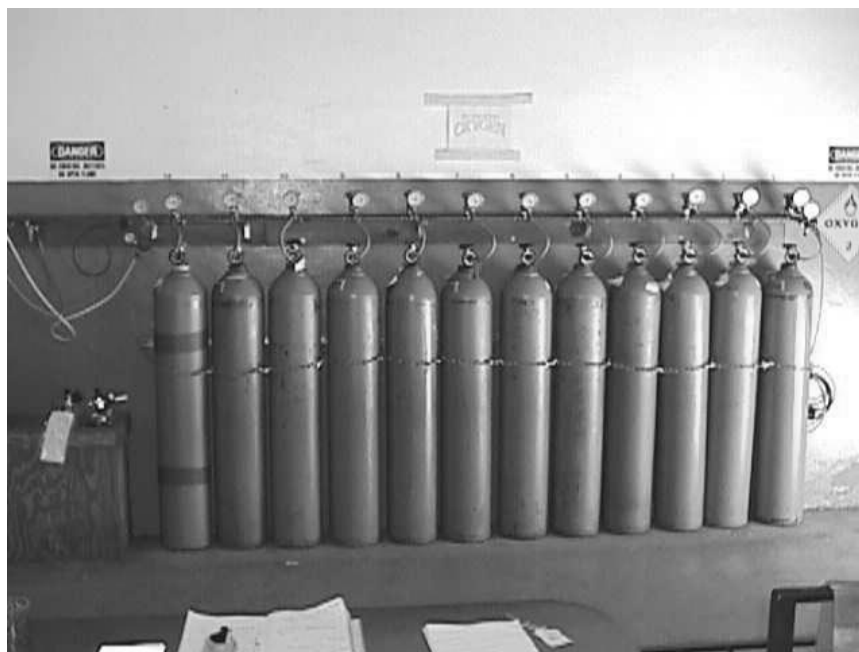
Photo 4: This photo depicts the cascade system used by the fire department to refill the oxygen cylinders. The cascade system is composed of 12 M-size (300 cubic foot) cylinders connected in series.

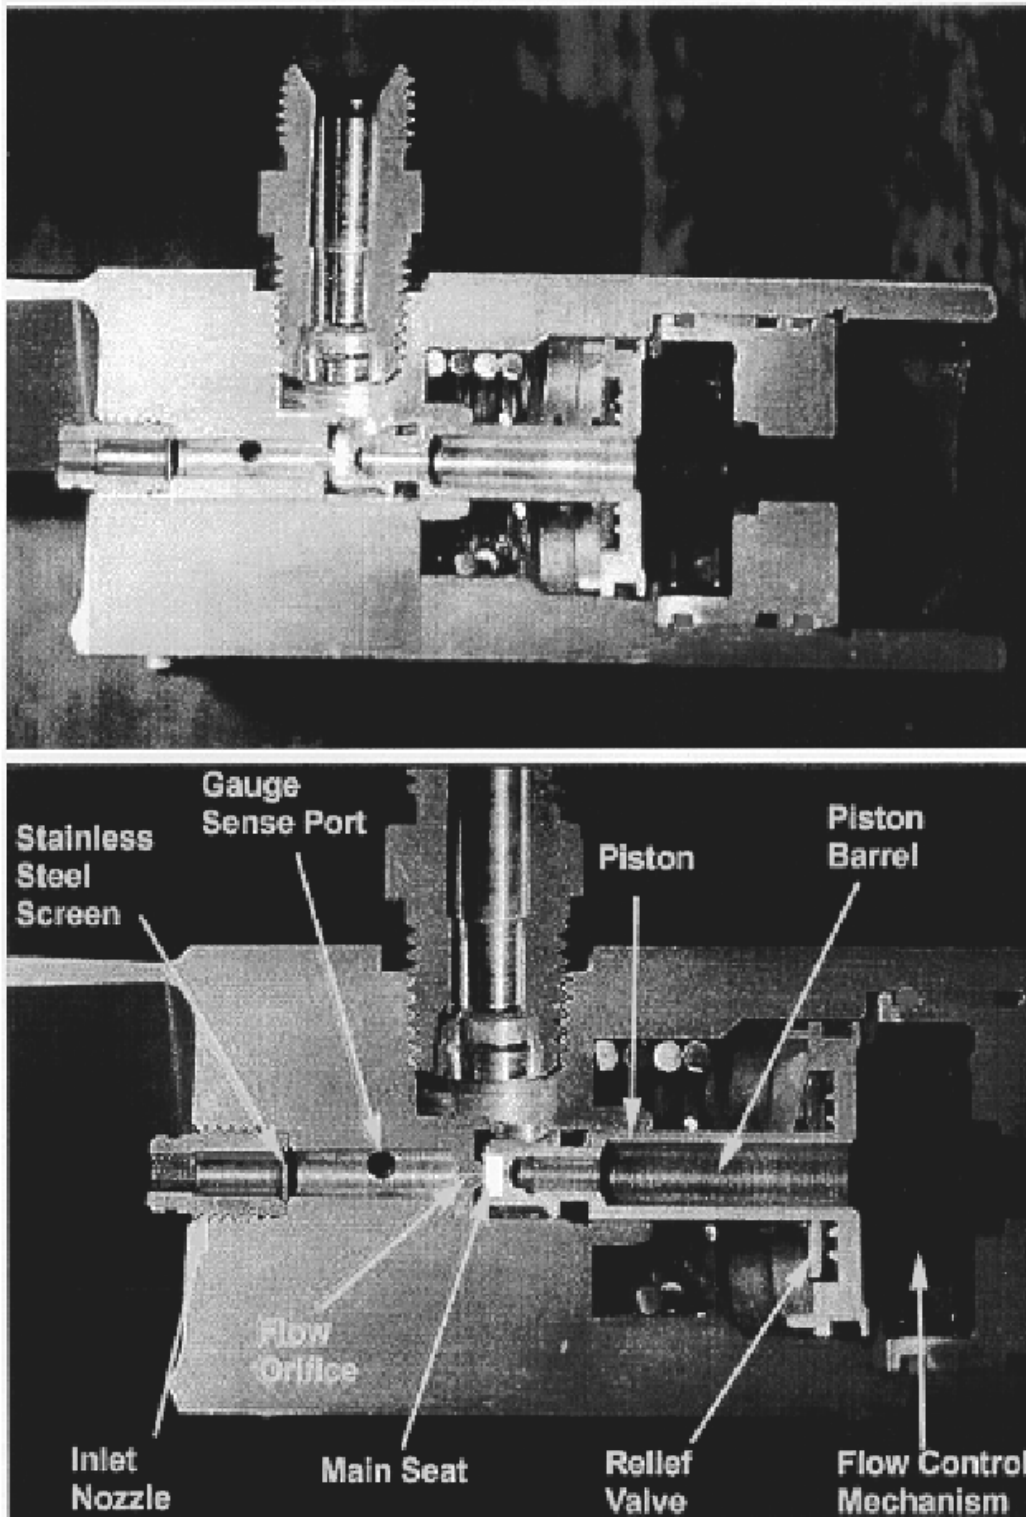
and ignited as it made contact with the bronze sintered-inlet filter (identified as a stainless steel screen on Diagram 1). Testing indicates that while bronze has been shown to resist ignition and sustained combustion at these pressures, the thin cross-section of the filter and the very close proximity to the aluminum body provides for a kindling path to the aluminum body for particle impact ignitions on the surface of the filter. While bronze is resistant to ignition, experience has shown that sintered filters can melt and break apart when exposed to a strong ignition mechanism like particle impact.

The regulator involved in the incident was an aluminum body regulator with a bronze sintered-inlet filter housed inside an aluminum downstream flow path. The design of the high-pressure section provides minimal protection of the highly flammable aluminum to promoted ignition mechanisms. Further, the significant amount of aluminum in this regulator, directly exposed to the high pressure environment and oxygen flow, produced a design that is susceptible to an ignition. The design also allows for combustion in the high-pressure port to punch through the main seat in the regulator (Diagram 1) directly and progress into the piston barrel leading to rapid involvement of the low-pressure components and venting of combustion by-products outward (through the vent ports), potentially towards the operator. Some regulators used by the fire and EMT services have aluminum bodies that are equipped with brass or bronze components in the downstream flow path, and these components are very resistant to particle impact. Bronze or brass, which are both non flammable at the pressures in the regulator and do not ignite by particle impact, act as a shield between the particle that ignites and the aluminum body. In this type of design, a particle ignition usually will burn itself out before kindling the ignition and combustion of surrounding materials.

Experts suggest that the design of the regulator involved in this incident allowed for combustion in the high-pressure port to punch through the main seat directly and progress into the piston barrel, leading to rapid involvement of the low-pressure components and venting of combustion byproducts outward (through the vent ports),

Diagram 1: Cut-away section from a regulator similar to the one that was involved in the incident

In this incident, the regulator (with the aluminum flow path) could not contain the ignition of the particle impact. The significant amount of aluminum in this regulator, directly exposed to the high-pressure environment and oxygen flow, produced a design that was susceptible to an ignition mechanism of this nature. The testing laboratory recommended that the flow path should be constructed of a metal such as brass or bronze to reduce the risk of a flash.

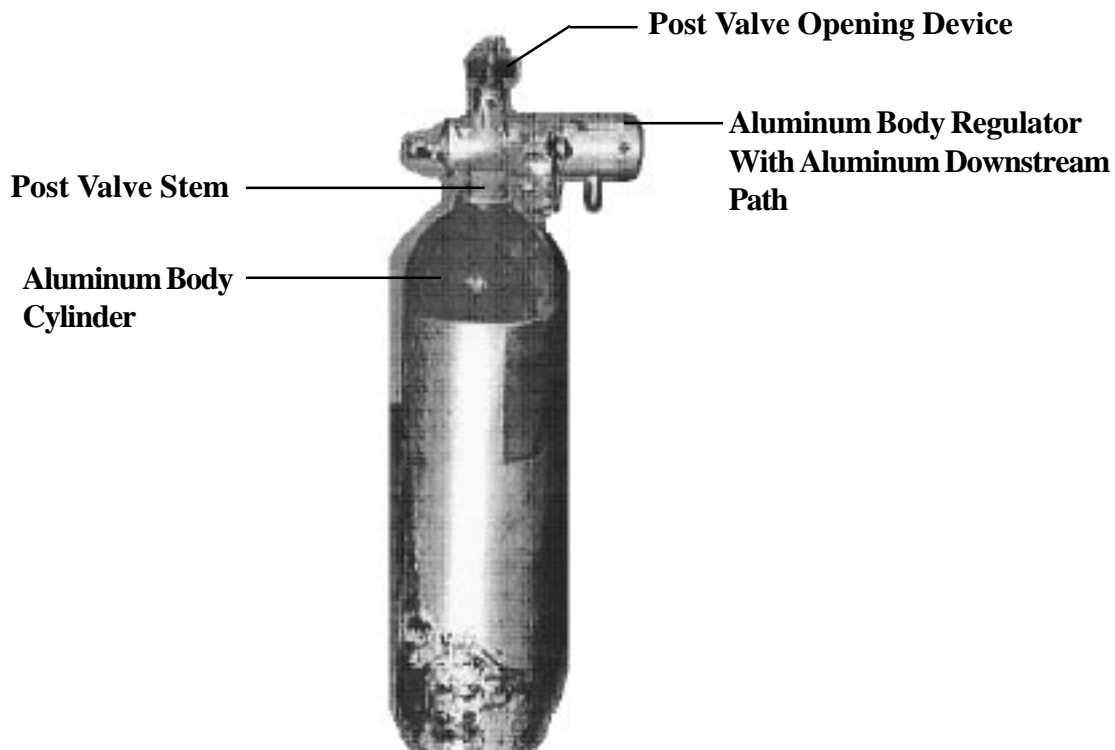
The cylinder has a post valve that closes off the oxygen opening and allows the regulator to attach (Diagram 2). When the post valve is screwed into the aluminum cylinder, there is a possibility that the two metals rubbing together (galling) could create metal particles that would remain enclosed in the cylinder body. Galling is a condition involving smearing and transfer of material from one surface to the other and particles could be introduced by metal-to-metal of seals rubbing which occurs when the post valve is opened and closed. The frictional heat of the galling could lead to ignition of the valve; or the particles generated by the galling could cause malfunction or ignition of another component within the regulator. Therefore, the design of the regulator's flow path should be resistant to ignition if particles should occur. Experts suggest the regulator flow path should be lined with brass, bronze, or a similar material which would resist particle ignition, and that using such a material would shield the particle ignition and provide the opportunity to burn out. Particulate migration

Diagram 2: This diagram depicts the cylinder involved in the incident and the location of the post valve stem.

from the cylinder can be minimized by the installation of a standoff tube (bayonette) at the inlet of the post valve.
